1. Town Lexington

15-17 Waltham St.

Minuteman Barber Shop

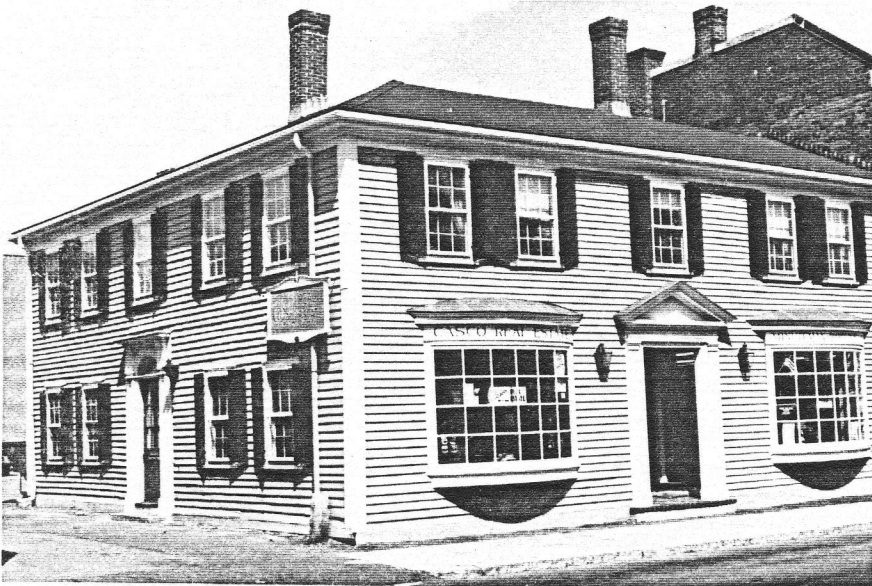
Exterior wall fabric Clapboard

Other features facade facing street; 5 bays
wide, center entrance, hip roof. First floor
altered with shop windows, barber pole on
(over)

right corner, carved, painted; front door triangular pediment, fluted pilasters-may be old, door itself removed to create ^{P.S.} store entrances in old stair porch. Hip roof. 2nd floor level clapboards w. beveled ends; windows 6 x 6. Ell on left (Munroe Tavern) 5 bay block at right angles to street block. Center chimney hip roof. Beveled clapboards. Door w. recessed paneled pilasters, fanlight over door only. no side lights. Entablature surrounding fanlight; granite post at SW corner of building.
